# Peach Lake Limnological Study and Management Plan Ogemaw County, Michigan

Prepared by: Restorative Lake Sciences Jennifer L. Jermalowicz-Jones, PhD, CLP www.restorativelakesciences.com

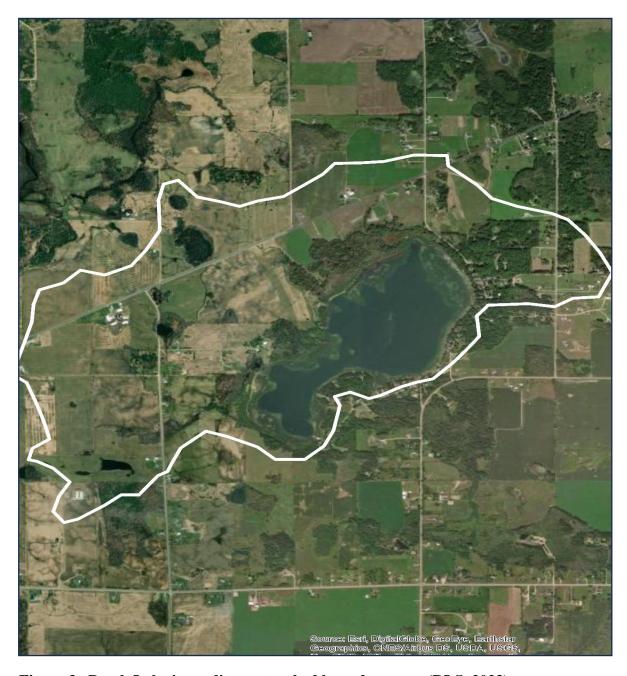
Figure 3. Peach Lake immediate watershed boundary map (RLS, 2023).

The immediate watershed, which is the area directly draining into the lake, is approximately 1,312 acres which is about 5.6 times the size of the lake and considered a moderately-sized immediate watershed. The lake has four unnamed inlets and an outlet (Peach Lake Creek). The outlet connects the West Branch Rifle River to the lake and the former is a designated trout stream. The lake supports a diverse application of land uses such as wetlands, beachfront for swimming, and agricultural and forested lands.

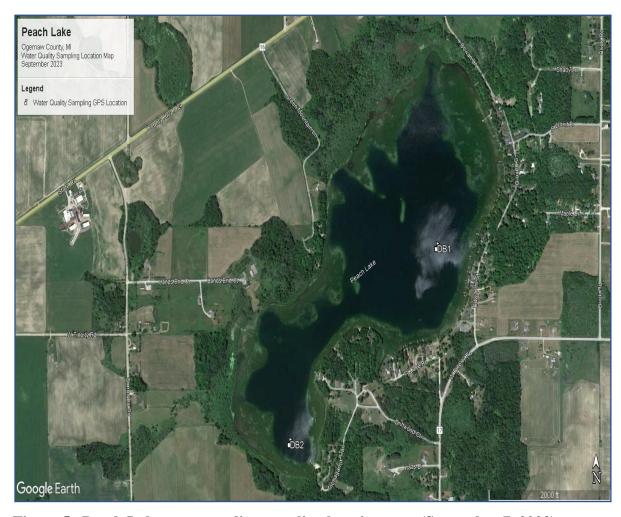
Figure 5. Peach Lake water quality sampling location map (September 7, 2023).

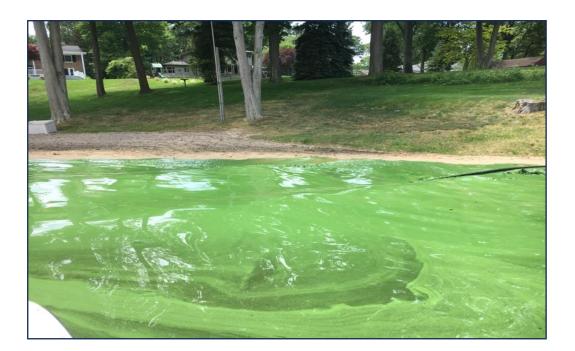
Figure 7. A blue-green algal bloom with surface scum on an inland Michigan lake.

The blue-green algae, Microcystis aeruginosa (Figure 8) and Oscillatoria rubescens (Figure 9) were prevalent algae in the lake which are indicators of poor water quality in that they can form prominent surface scums or blooms. Such blue-green algal blooms have occurred on Peach Lake beginning in 2020 through this year. *Microcystis* colonies are a few micrometers in diameter and are evenly distributed throughout a gelatinous matrix. Younger colonies are spherical and older ones are more irregularly shaped. There are numerous gas vesicles, and the algae can thrive at the surface with minimal photo-degradation (breaking down) by the sun. When the sunlight is excessive, the algae can break down and release toxins and lower the dissolved oxygen in the water column. The algae are the only type known to fix nitrogen gas into ammonia for growth. Microcystis has also been shown to overwinter in lake sediments (Fallon et al., 1981). In addition, it may thrive in a mucilage layer with sediment bacteria that can release phosphorus under anaerobic conditions (Brunberg, 1995). They assume a high volume in the water column (Reynolds, 1984) compared to diatoms and other single-celled green algae. The blue-green algae have been on the planet nearly 2.15 billion years and have assumed strong adaptation mechanisms for survival. In general, calm surface conditions will facilitate enhanced growth of this type of algae since downward transport is reduced. Microcystis may also be toxic to zooplankton such as Daphnia which was a zooplankton present in Peach Lake and in most lakes (Nizan et al., 1986). Without adequate grazers to reduce algae, especially blue-greens, the blue-green population will continue to increase and create negative impacts to water bodies such as Peach Lake.

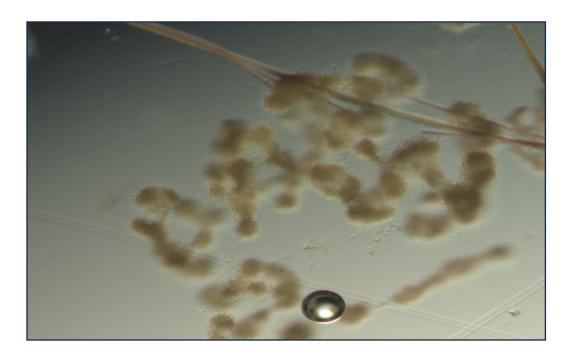
Figure 8. Microscopic image of Blue-green algae (*Microcystis aeruginosa*) in a Peach Lake water sample (September 7, 2023).

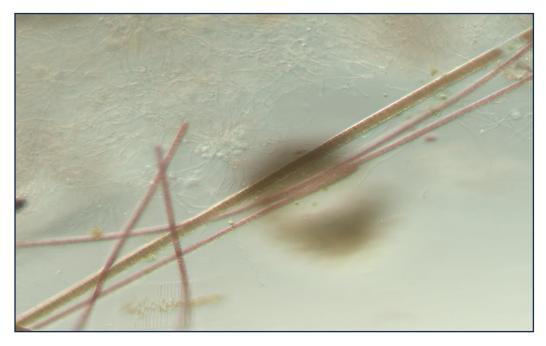
Figure 9. Microscopic image of Blue-green algae (Oscillatoria rubescens) in a Peach Lake water sample (September 7, 2023).

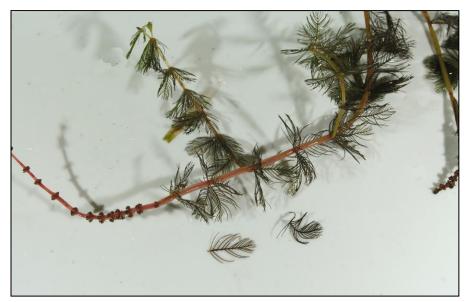
Figure 29. Hybrid Eurasian Watermilfoil plant with seed head and fragments (©RLS).

Eurasian Watermilfoil growth in Peach Lake is capable of producing dense surface canopies, even despite the deeper waters as most of the littoral zone could be infested if not controlled. Figure 31 shows the distribution of milfoil within Peach Lake (1.1 acres). Table 12 displays the various invasives found and their relative abundance in Peach Lake.

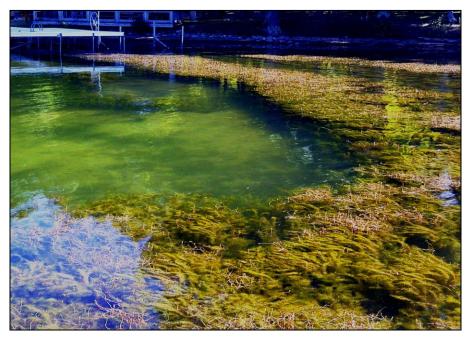
Figure 30. Eurasian Watermilfoil canopy on an inland lake  $( \mathbb{O} RLS )$ .

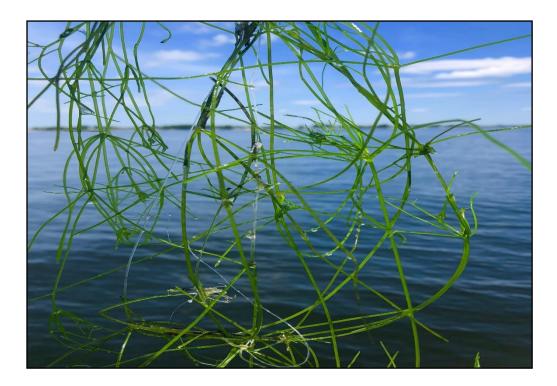
Figure 32. A Starry Stonewort cluster from an inland lake (©RLS).

Starry Stonewort (*Nitellopsis obtusa*; Figure 32) is an invasive macro alga that has invaded many inland lakes and was originally discovered in the St. Lawrence River. The "leaves" appear as long, smooth, angular branches of differing lengths. The alga has been observed in dense beds at depths beyond several meters in clear inland lakes and can grow to heights in excess of a few meters. It prefers clear alkaline waters and has been shown to cause significant declines in water quality and fishery spawning habitat Individual fragments can be transported to the lake via waterfowl or boats. It was found in approximately 2.5 acres of Peach Lake (Figure 33). It can be removed without chemicals through the use of diver-assisted suction harvesting (DASH) or through the use of contact herbicides of algaecides.

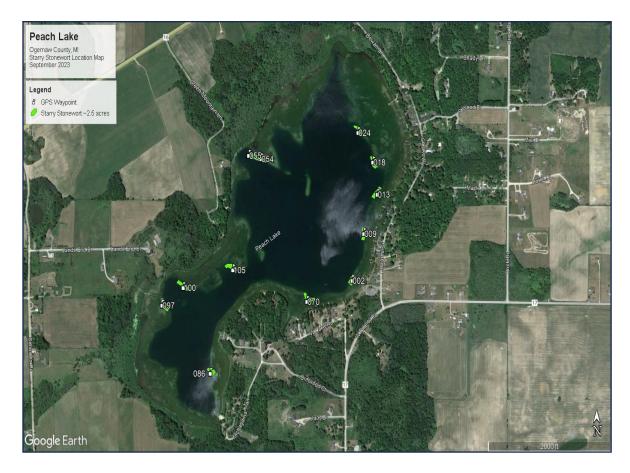
Figure 33. Distribution of Starry Stonewort in Peach Lake (September 7, 2023).

Aquatic Plant Common Name	Aquatic Plant Latin Name	A level	B level	C level	D level	# Sites Found (% of total)
Eurasian Watermilfoil	Myriophyllum spicatum	1	1	1	3	5.7 (1.1 acres)
Starry Stonewort	Nitellopsis obtusa	6	12	2	0	19.0 (2.5 acres)
Common Reed	Phragmites australis	2	0	0	0	2 sites

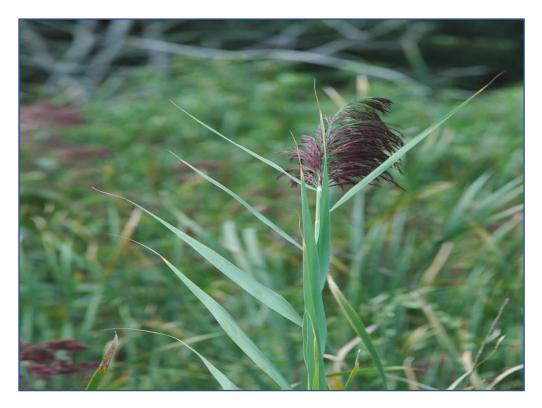
Figure 34. The invasive emergent Phragmites (©RLS).

The Giant Common Reed (*Phragmites australis*; Figure 34) is an imminent threat to the surface area and shallows of the lake since it may grow submersed in water depths of  $\geq 2$  meters (Herrick and Wolf, 2005), thereby drying up wetland habitat and reducing lake surface area. In addition, large, dense stands of *Phragmites* accumulate sediments, reduce habitat variability, and impede natural water flow (Wang et *al.*, 2006). This plant was found in two locations along the north and southeast regions of the lake. A map showing the distribution of the emergent invasive Phragmites can be found in Figure 35. It is best removed manually to avoid the use of aquatic herbicides that can result in negative impacts to soil macroinvertebrates and wildlife. Care must be taken to ensure that the underground stolons are removed in addition to the seed heads and standing crop biomass.

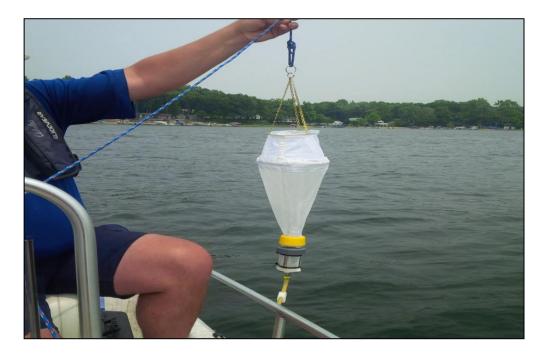
Figure 36. A zooplankton collection tow net (RLS).

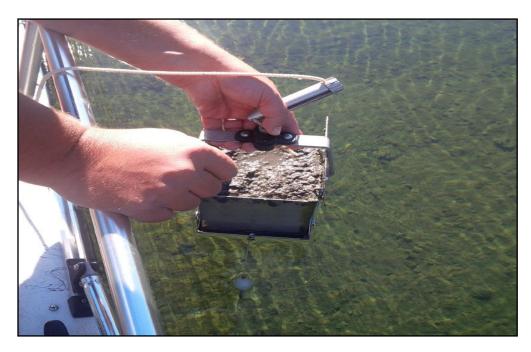
Figure 37. An Ekman hand dredge for sampling lake sediments (RLS).

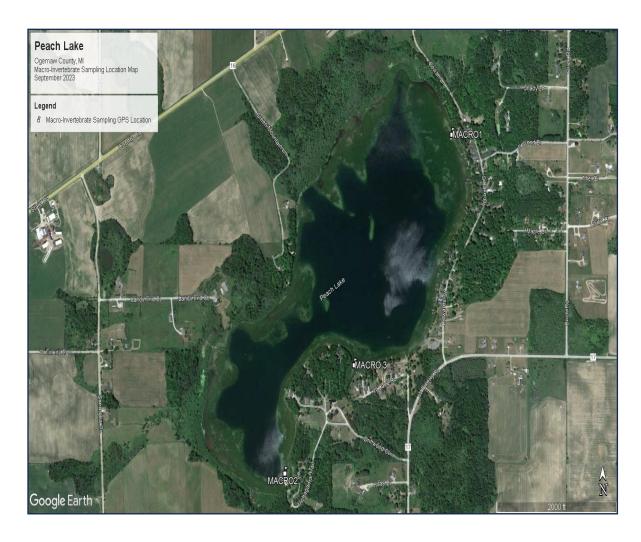
Figure 38. Peach Lake macroinvertebrate sampling locations (RLS, 2023).

Genera found in the sediment samples included midges (Chironomindae), jute snails (Pleuroceridae), wheel snails (Planorbidae), pond snails, fingernail clams, zebra mussels, and pond snails. Of all the species found, all were native except for the Zebra Mussels that arrived from the Caspian Sea several decades ago. Many of these genera are located universally in low quality and high-quality water. The midge larvae family Chironomidae can be found in both high- and low-quality water (Lenat and Barbour 1994). Table 14 displays the taxa and abundance found at the three sampling sites (Figure 38).

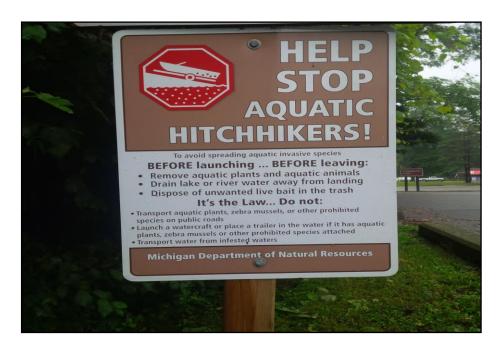
Figure 39. An aquatic invasive prevention sign for boat access sites.

The first ingredient to successful prevention of unwanted transfers of exotic species to is awareness and education (Figure 39). The majority of the exotic species of concern have been listed in this report. Other exotic species on the move could be introduced to the riparians around the lakes through the use of a professionally developed educational newsletter and/or through regular lake seminars or workshops.

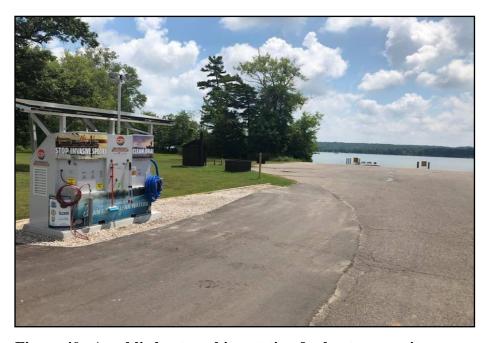
Figure 40. A public boat washing station for boat access sites.

Critical elements of this education include: 1) How to approach boaters, 2) Demonstration of effective boat and trailer inspections and cleaning techniques, 3) The recording of important information, 4) Identification of high-priority invasive species, and 5) Sharing findings with others. If a boat washing station is situated on Peach Lake, the Township and/or Association should work together to educate the public and lake users on proper cleaning techniques and other invasive species information. A "Landing Blitz" can be held once the station is in place and the public can be invited to a field demonstration of how to use the washing station. A typical boat washing station typically costs around \$30,000 (Figure 40) but lower cost ones are available for private lakes with restricted access (e.g., hand-held sprayer units).

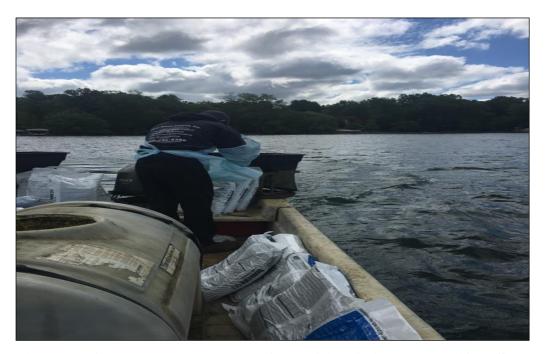
Figure 41. A boat used to apply aquatic herbicides in inland lakes (©RLS).

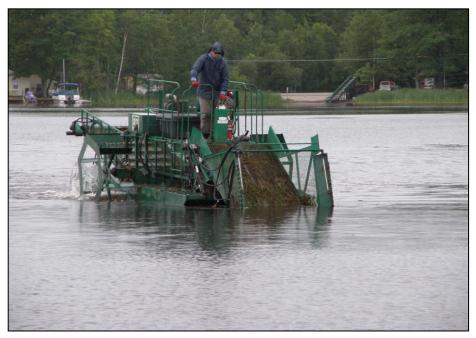
Figure 42. A mechanical harvester used to remove aquatic plants (©RLS).

Mechanical harvesting is usually not recommended for the removal of Eurasian Watermilfoil or Starry Stonewort since the plants may fragment when cut and re-grow on the lake bottom. It is therefore not necessary for Peach Lake at this time. It could be used for future natural removal of nuisance native aquatic vegetation if it becomes problematic.

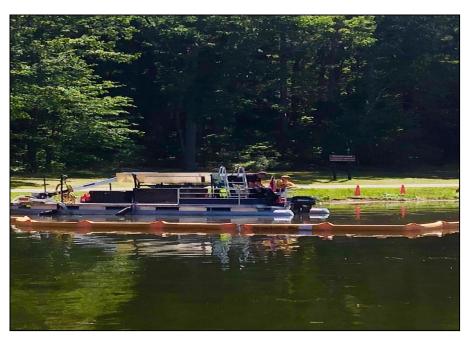
Figure 45. A DASH boat used for aquatic plant removal (©RLS).

Suction harvesting via a Diver Assisted Suction Harvesting (DASH) boat (Figure 45) involves hand removal of individual plants by a SCUBA diver in selected areas of lake bottom with the use of a hand-operated suction hose. Samples are dewatered on land or removed via fabric bags to an offsite location. This method is generally recommended for small (less than 1 acre) spot removal of vegetation since it is costly on a large scale. It may be used in the future to remove small areas of dense growth in shallow areas and for the removal of Starry Stonewort.

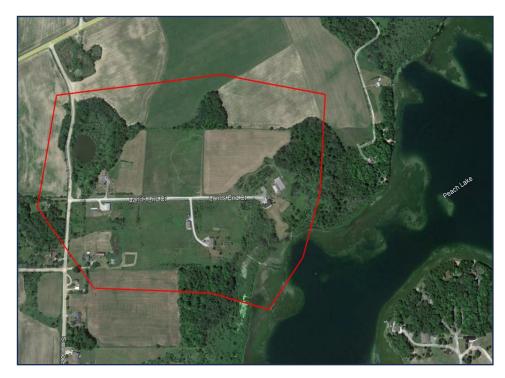
Figure 46. An area of concern from Peach Lake residents on the west side of Peach Lake. Photo provided by West Branch Township.

The most likely impairments to the water quality of Peach Lake are agricultural fields and residential septic systems. There is a strong need for additional evaluation of all nutrient loading into the lake, which is resulting in internal loading of nutrients within the lake basin that is ultimately causing blue-green algal blooms and accelerated aquatic vegetation growth and other water quality impairments. The following sections focus on these issues and recommendations for improvements.

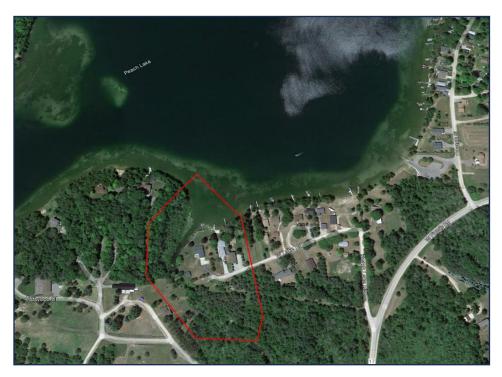
Figure 47. An area of concern from Peach Lake residents on the south shore of Peach Lake near the outlet. Photo provided by West Branch Township.

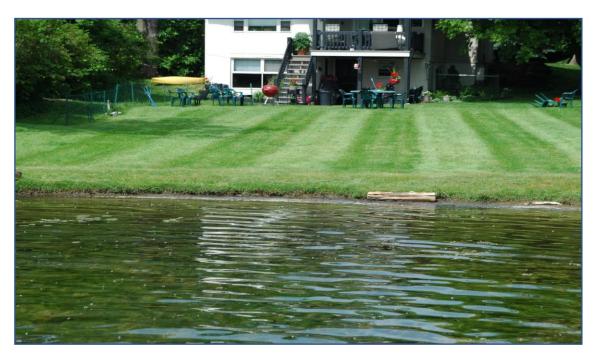
Figure 50. An example of poor shoreline management with no vegetation buffer present.  $\bigcirc$ RLS

As an additional bonus, Canada geese (*Branta canadensis*) usually do not prefer lakefront lawns with dense riparian vegetation because they are concerned about the potential of hidden predators within the vegetation. Figure 50 demonstrates a lakefront property with poor management of the shoreline.
